# **NO-DIG DOWN UNDER** **MELBOURNE 2019**

## **Tauranga Southern Pipeline - Harbour Crossing**

John Stuart-Robertson

HDI Lucas, Brisbane, Australia

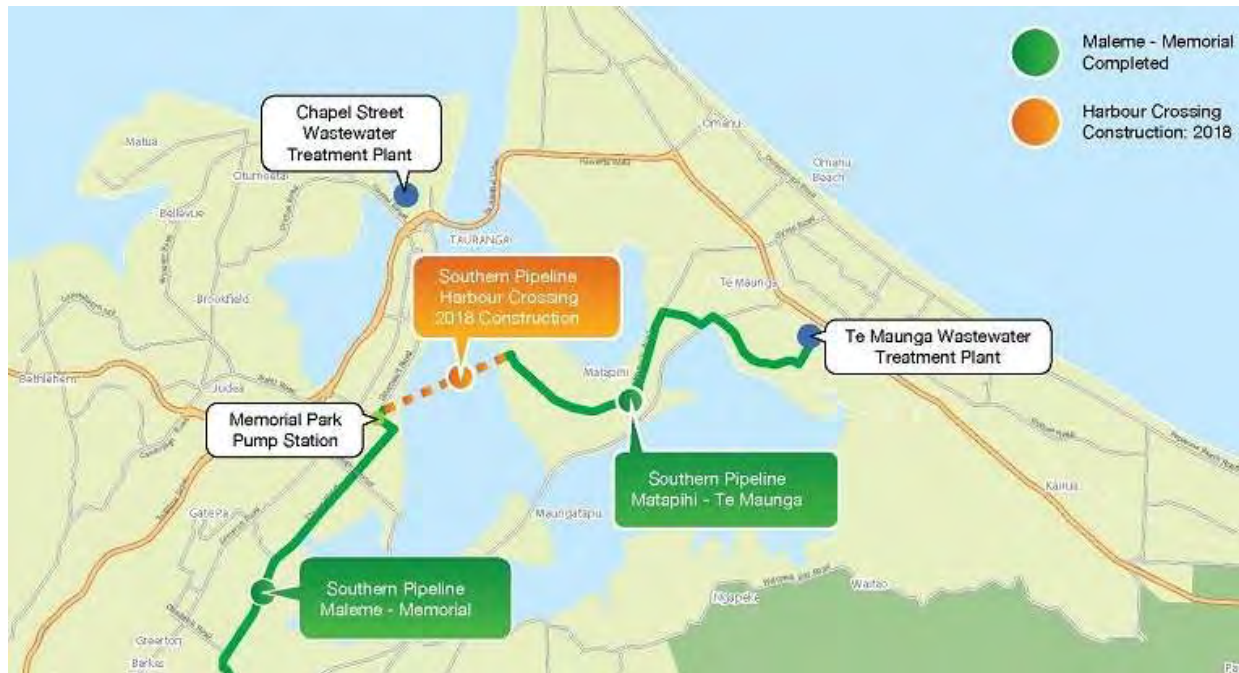
Figure 1 – Southern Pipeline Route

The route that offered the best result for the whole city was to bring the Southern Pipeline from Greerton to Memorial Park, then across the harbour to Matapihi. This option solved several wastewater network problems at once. It achieved the primary goal of diverting sewage from the southern catchments to the Te Maunga treatment plant, and it also offered more ability to relieve the overall wastewater burden that the wider city was placing on the Chapel Street treatment plant.

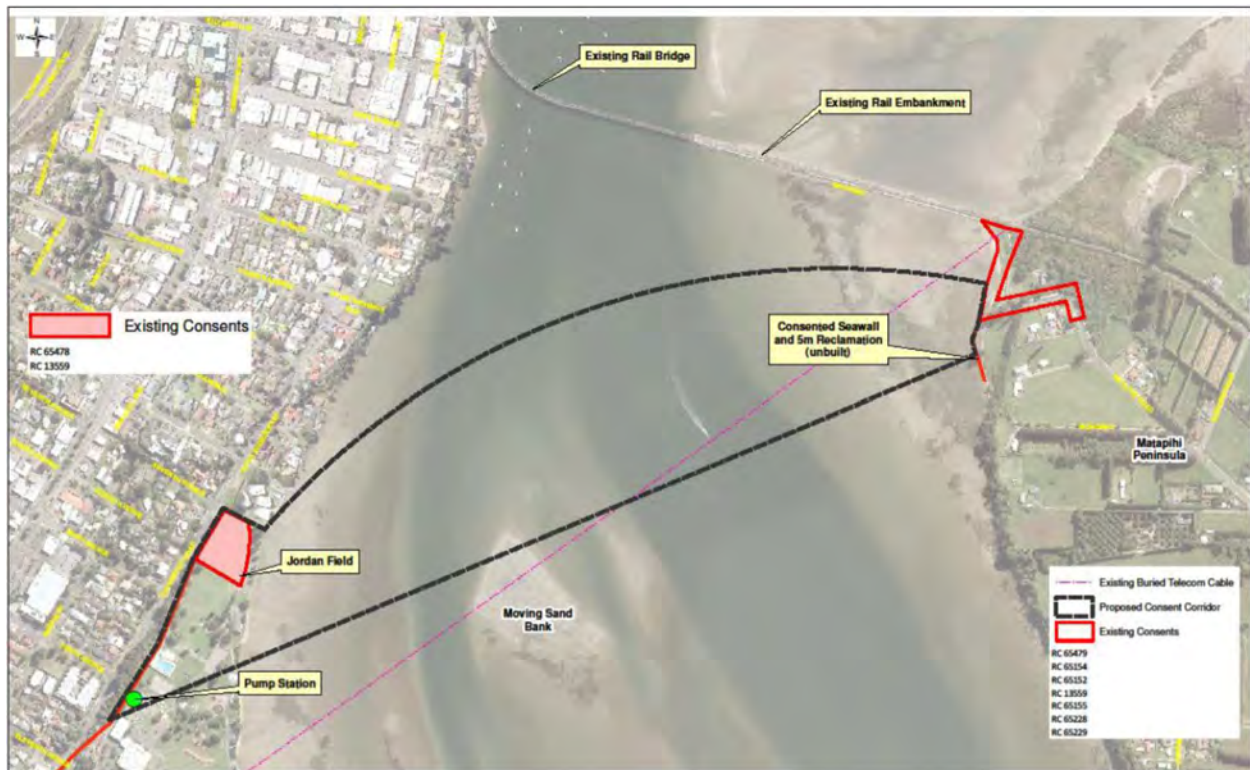
Figure 2 – Site Locations

The site encompasses two land sections being Memorial Park to the west and Matapihi Peninsula to the east. Memorial Park is relatively flat comprising grassed recreational and sports fields (Jordan Field), around 2m above sea level. There are also a recreation centre, swimming pool, pump station, skate park and rowing club.

Matapihi Peninsula has a relatively flat carpark and grassed reserve area about 1 to 2m above sea level before rising up a 10m high terrace. The pipe is then trenched across land and the road up the hill to connect with the existing pipe.

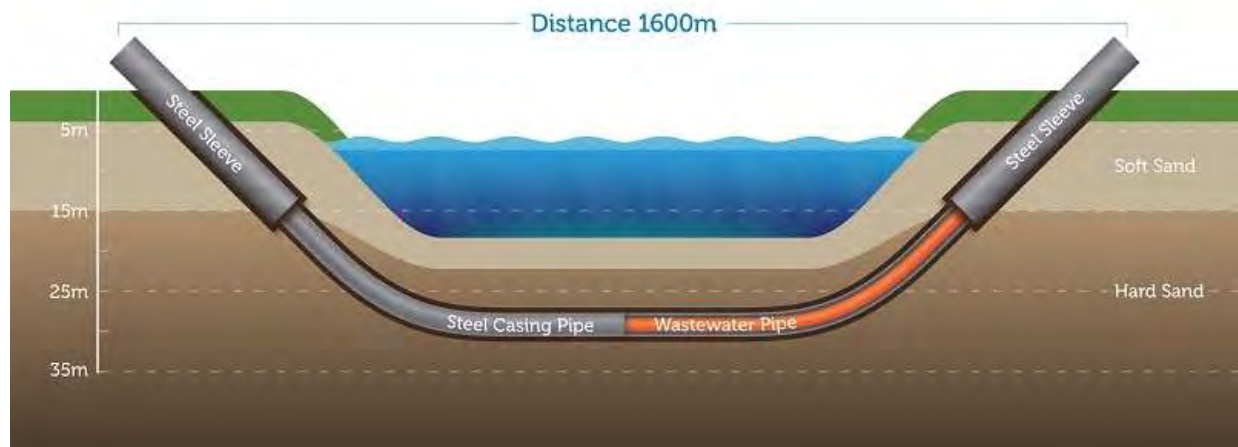
Figure 4- Final Crossing Concept

Again our proposal was successful and Brian Perry, Beca and Lucas were engaged to complete the installation of the crossing. The final plan was to install significant conductor casing on each side of the harbour so as to maintain a depth of cover at the shoreline. This required significant pits on each side to accommodate equipment. The steel casing pipe at 914mm diameter would be installed as 300m long strings with a DN800 HDPE pipeline of similar length strings to be inserted within the casing.

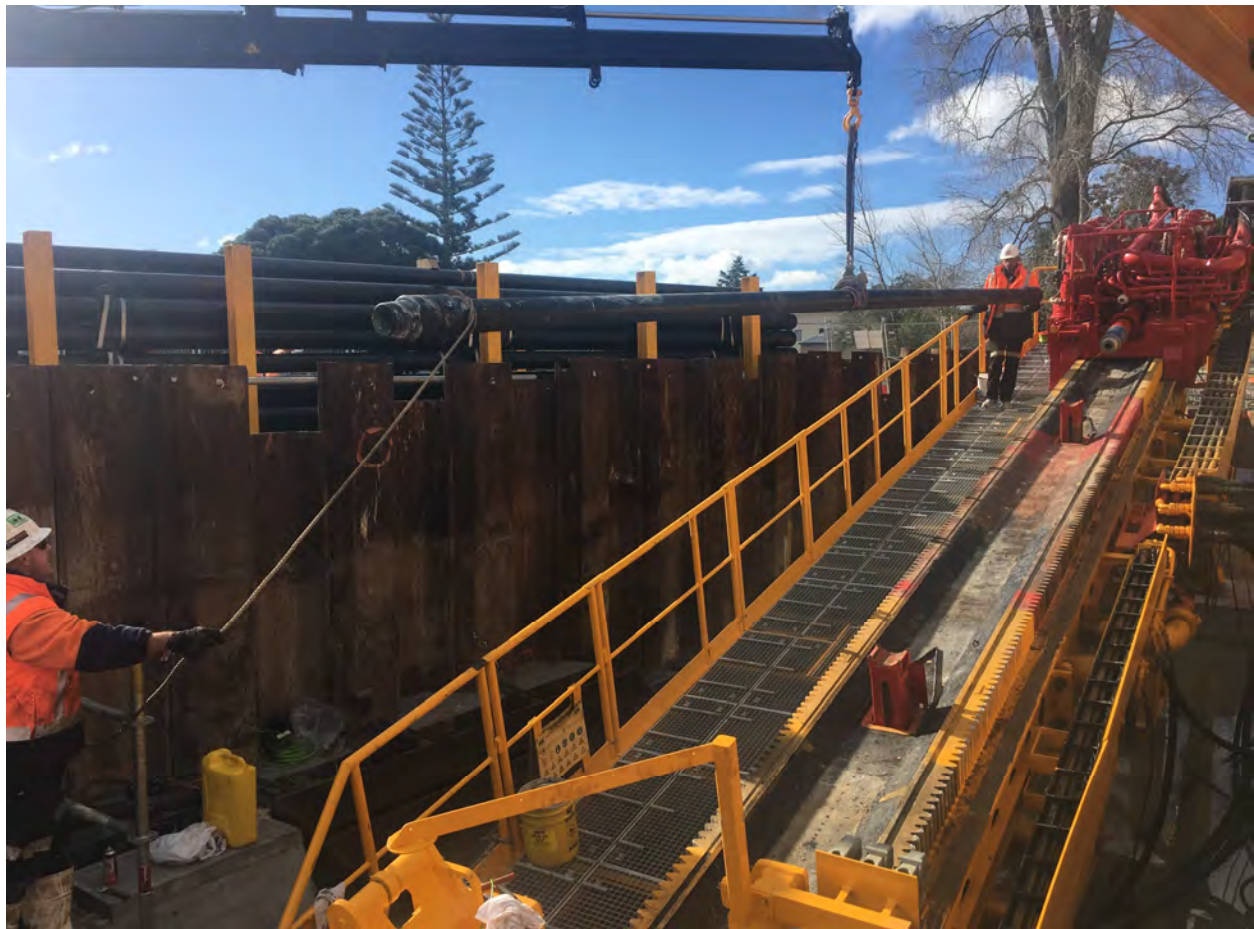
Figure 7 – HK400 Drill Rig

The key drilling equipment including our Herrenknecht HK400 Drill Rig, Gardner Denver PZ-8 pumps and Brandt drilling fluid processing units were mobilised from Australia.

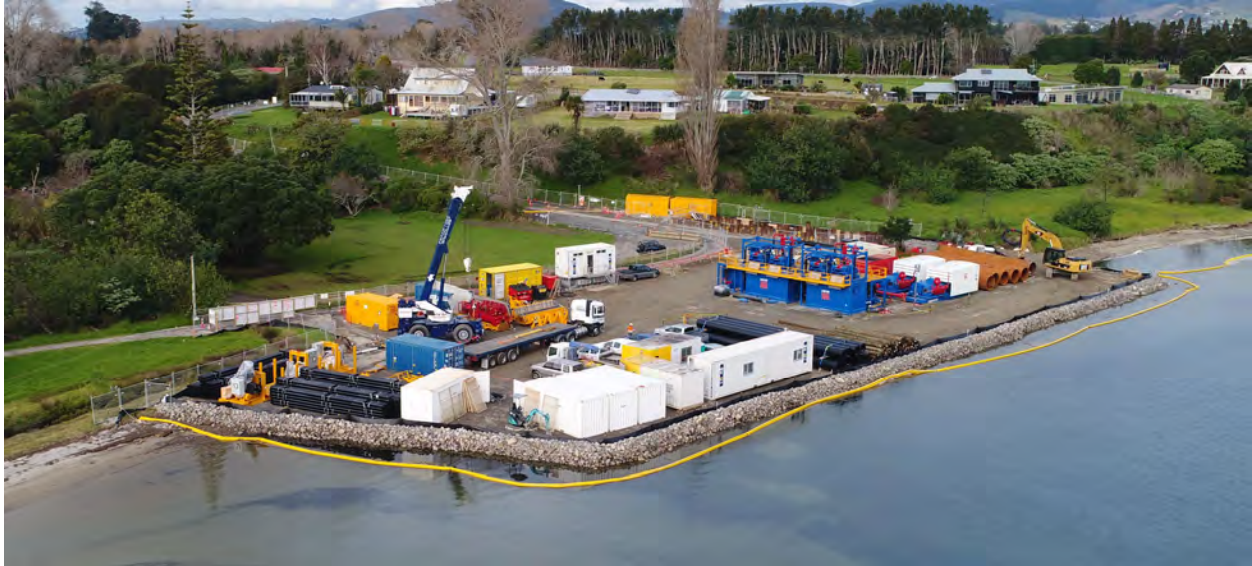
Figure 8 – Matapihi Site Location

A sheet pile pit to a depth of approx. 3m was installed so as to maintain a depth of cover at the shoreline of more 10 metres.

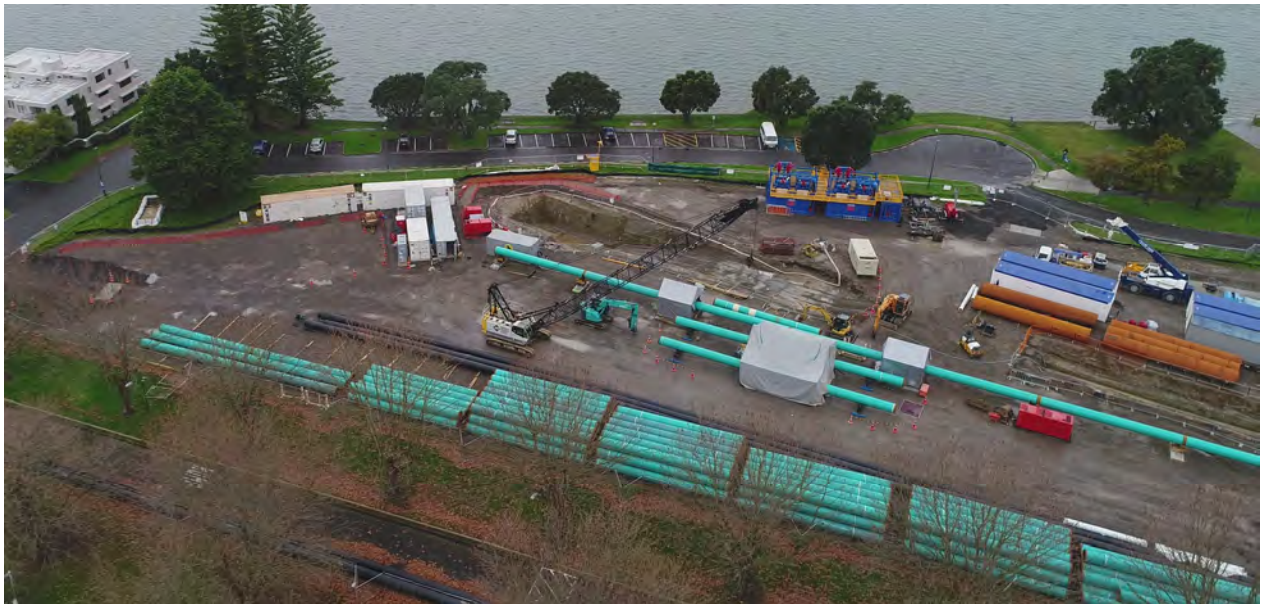
Figure 9 – Memorial Park Site Location

The Pipe side was at Memorial Park. An exit receipt portal was excavated for installation of the exit side casing.

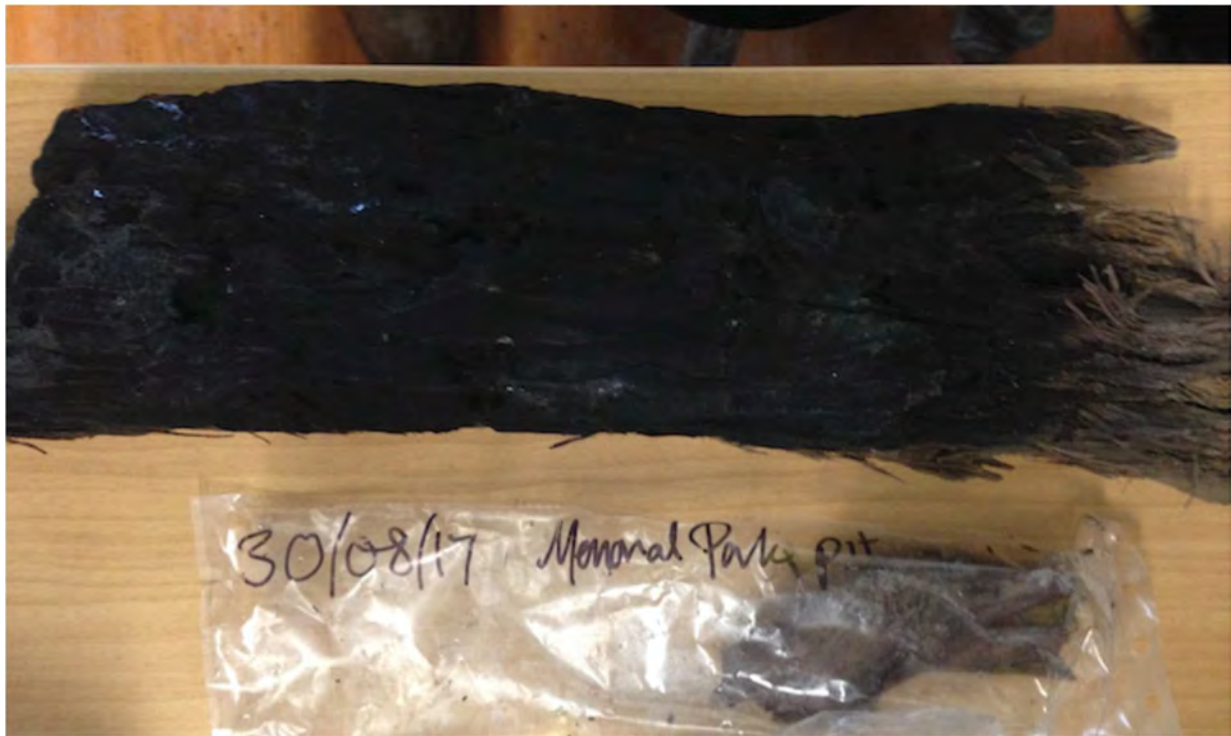
Figure 13- Totara

Despite these challenges and although not very common with latent condition circumstances, we were able to ascertain that the obstruction was timber deposits. Testing of timber recovered from the borehole revealed it to be Totara and approximately 50,000 years old. Several large pieces of timber were retrieved from the hole through junk basket runs and also by floating out of the hole.
